SERVICE BULLETIN 402

SUBJECT: Malformed GIII Adjustable Long Product Stops

MODELS: GIII Plus venders

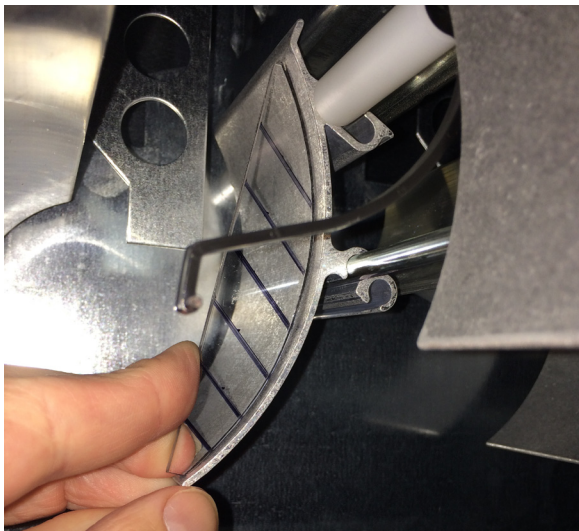
Figure 3. The product stop shown here is good. It conforms with the curve of the gauge.

To correctly identify any product stops that are suspected to be malformed, please contact Royal Vendors' Customer Service Department at 1-800-931-9214 (outside North America, dial +1 304-728-8363) to obtain a gauge. Using this gauge, verify that the curve of the long adjustable product stops is correct, as shown in the photographs at right and below.
